Engineered Solutions – From Concept to Completion

Re-Engineering of 'Pendolino' Toilet Installations

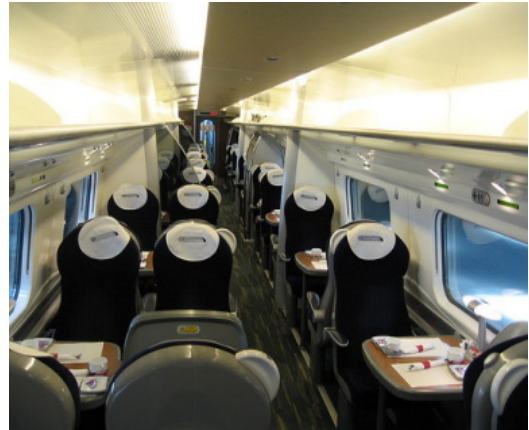
Flowonics was quickly able to identify the critical issues with the original toilet system design which caused the reported problems. Having done so, the original pipework components were redesigned as one-piece silicone items rather than the multi-piece hoses originally fitted. The new components were successfully trialled and Flowonics has supplied complete modifications kits to enable the installation of the new system on the entire 'Pendolino' fleet.

Working with Alstom Transportation, Flowonics Limited undertook a complete re-design of the toilet pipework systems, which has dramatically reduced the number of leaks and blockages. This has resulted in a significant improvement in the reliability of the toilets, greater unit availability and a more pleasant travelling experience for passengers.
